# Portage Creek Sediment Remediation Project Kalamazoo, Michigan

## Pre-Sediment Removal Structure Feature Assessment Removal Areas SA3-A, SA3-B and SA3-Access

F&V Project Number: 809930  
August, 2012

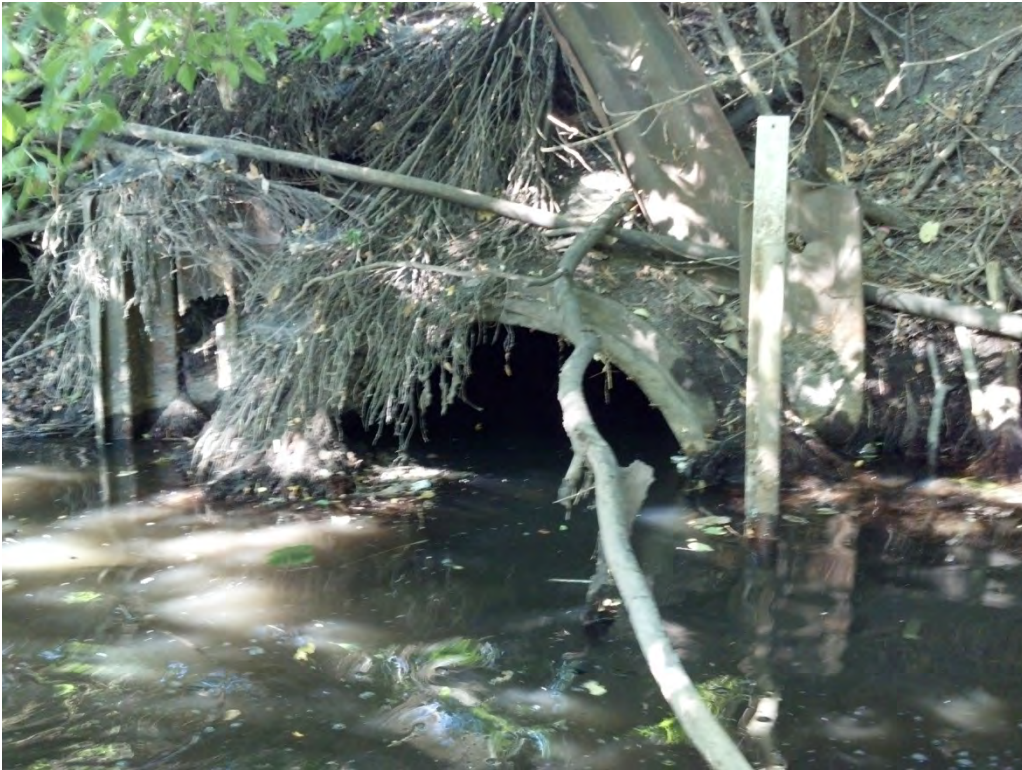
Concrete outlet in the southwest with failed sheet pile headwall

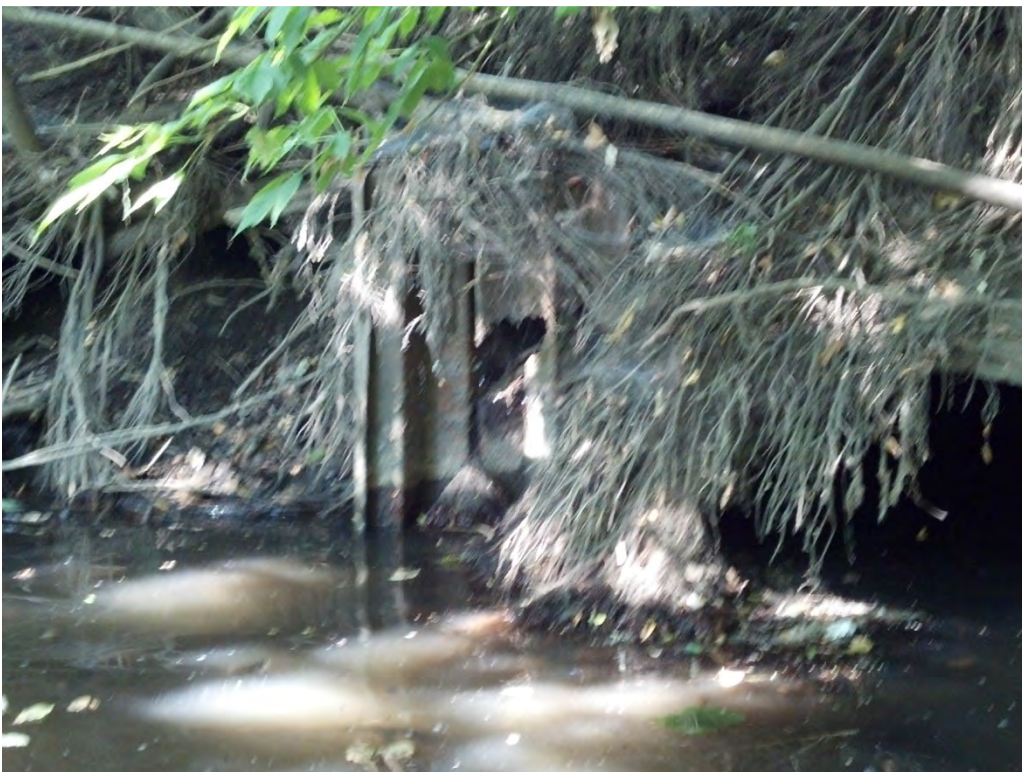
Failed sheet pile in the southwest

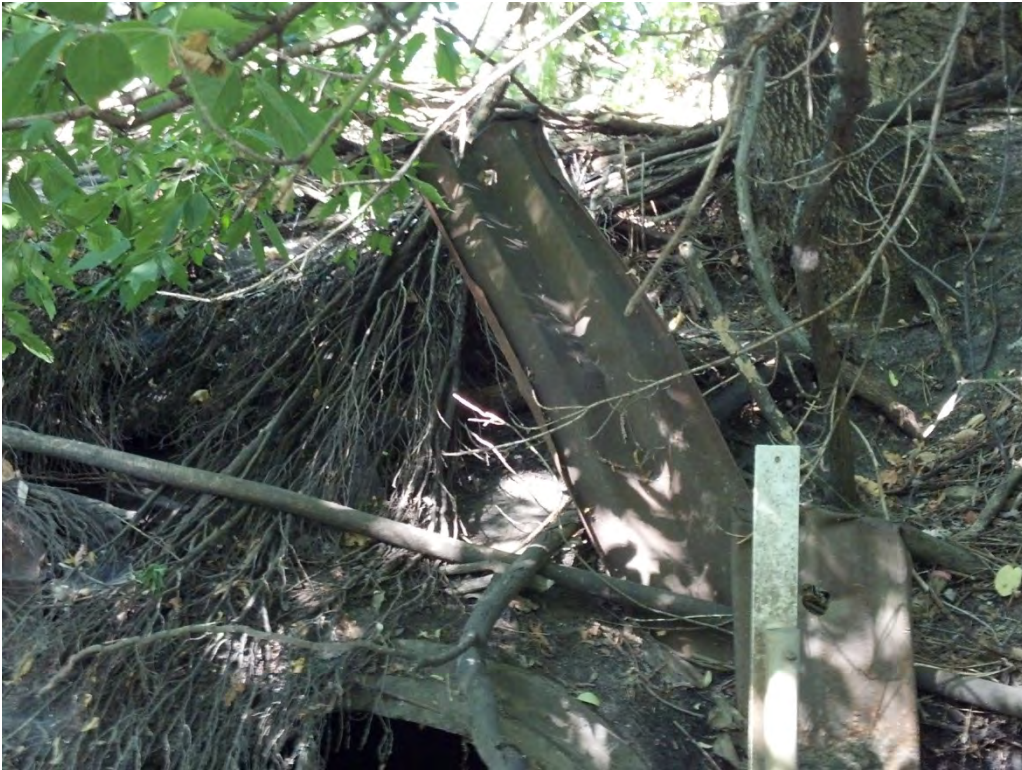
Failed sheet pile in the southwest

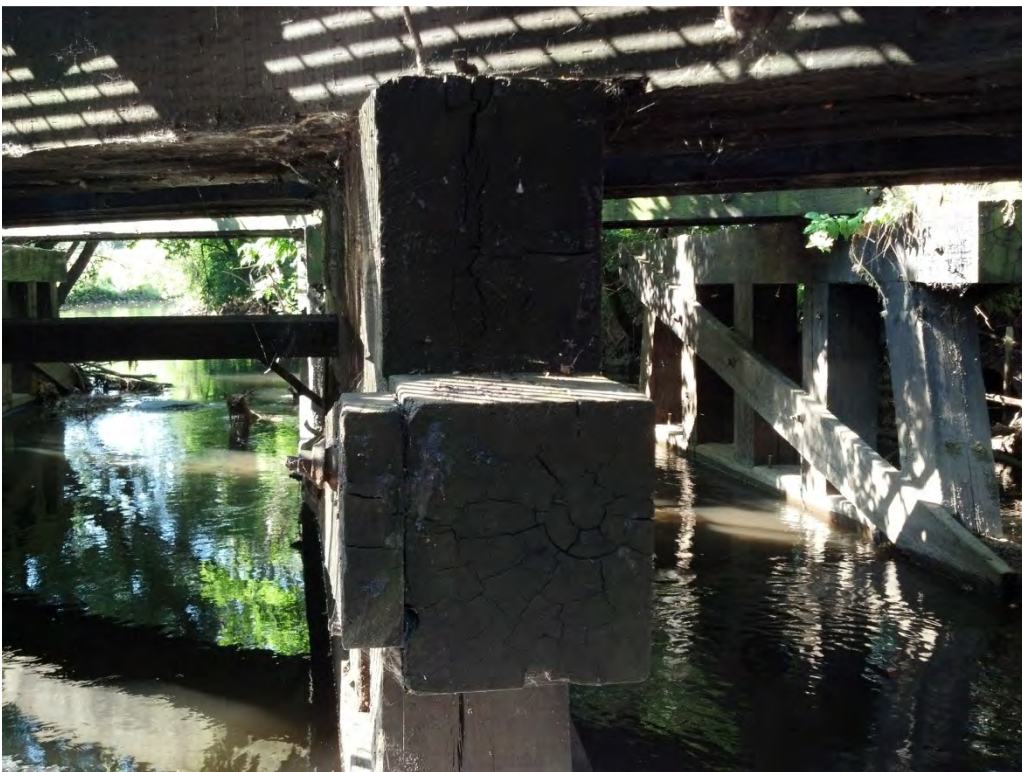
- There is a large amount of heavy woody debris on the upstream end of the structures.
- Moderate rot and section loss was noted on a number of ends of timber members.
- There is heavy brush growth encroaching on the structures.
- The timber lagging in the southeast has minor undermining.
- Scattered splitting and checking and creosote bleeding was noted in timber members.
- There is a 42" concrete outlet in the southwest bank. The bank in the area is supported by sheet piling, which has critical corrosion with holes in sheets and a number of failed sheets.
- There are conduits on the south side of the structure and one failed conduit on the north side hanging into the channel.
- Riveted steel girders have moderate corrosion and section loss.
- Railroad tie deck on tracked structures is newer timber.

Checking and splitting on ends of timber beams

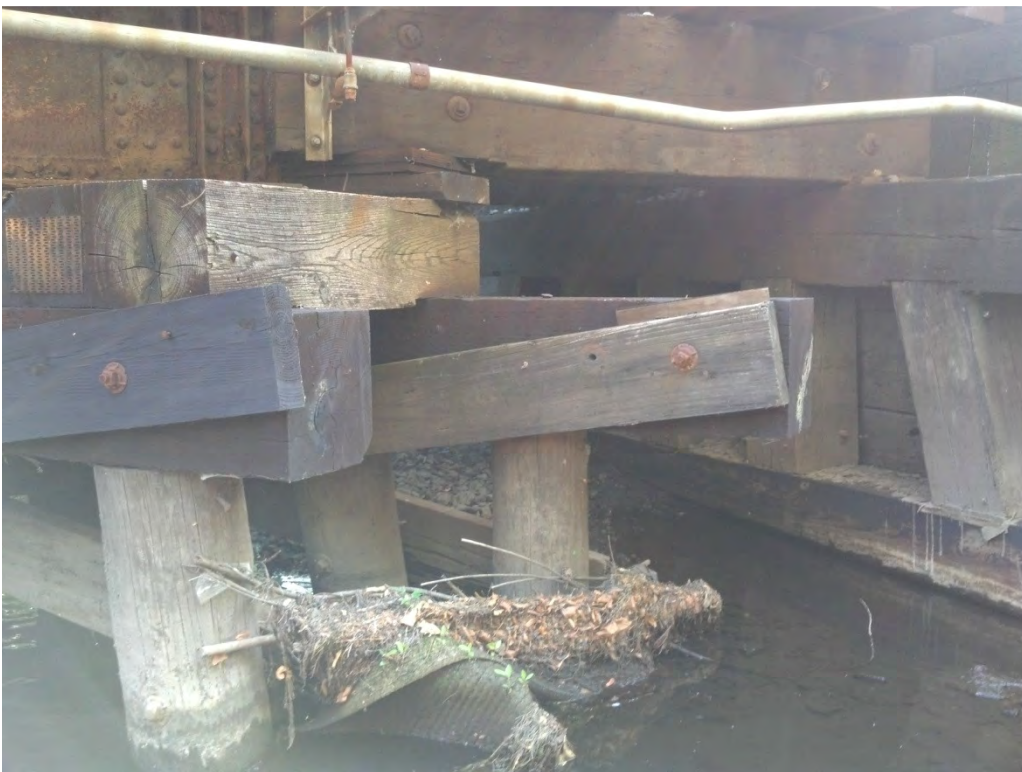
Debris on upstream end of structure

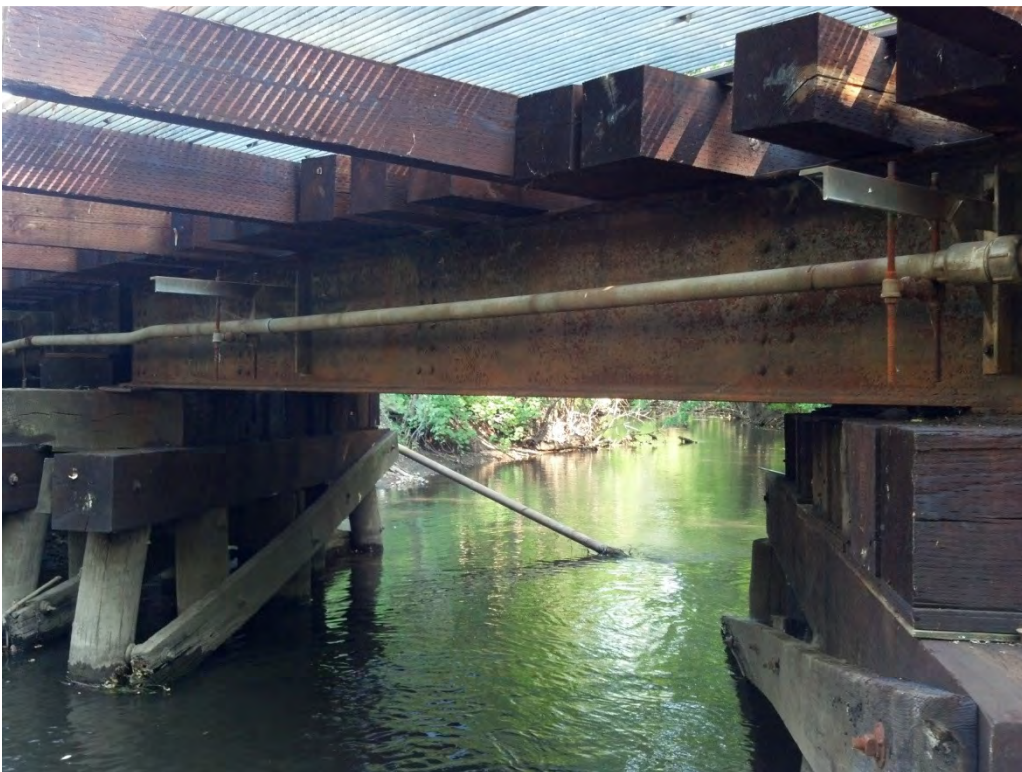
Corrosion and section loss on steel girder

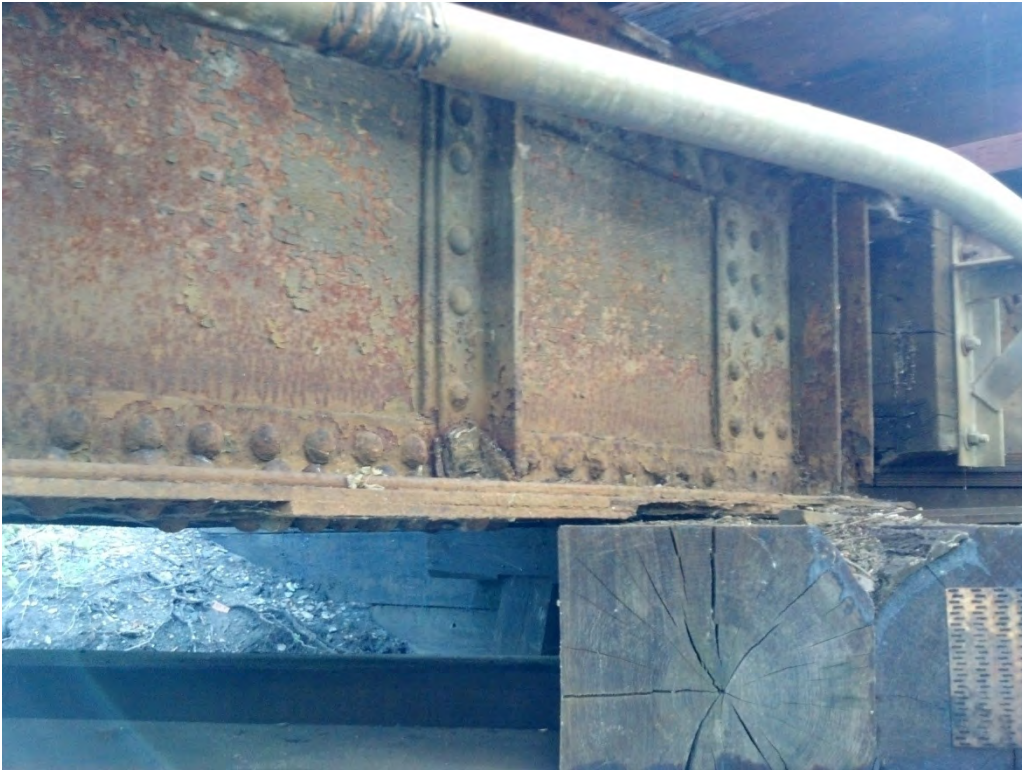
Corrosion and section loss on steel girder and checking on timber beam

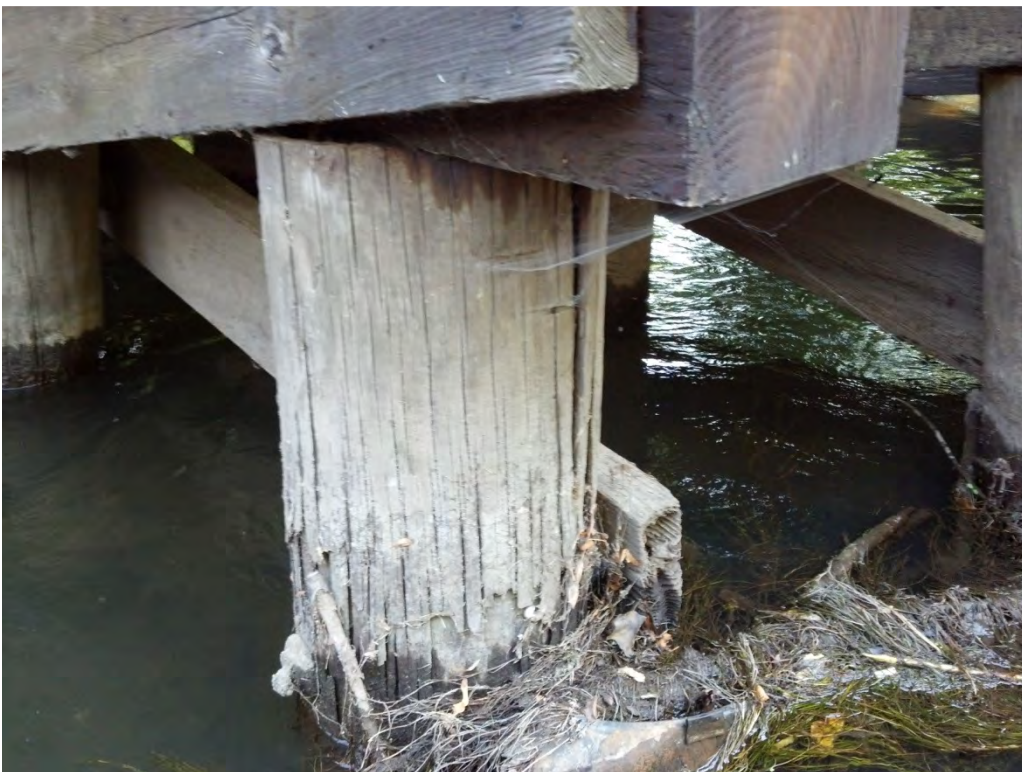
Brooming of timber pile

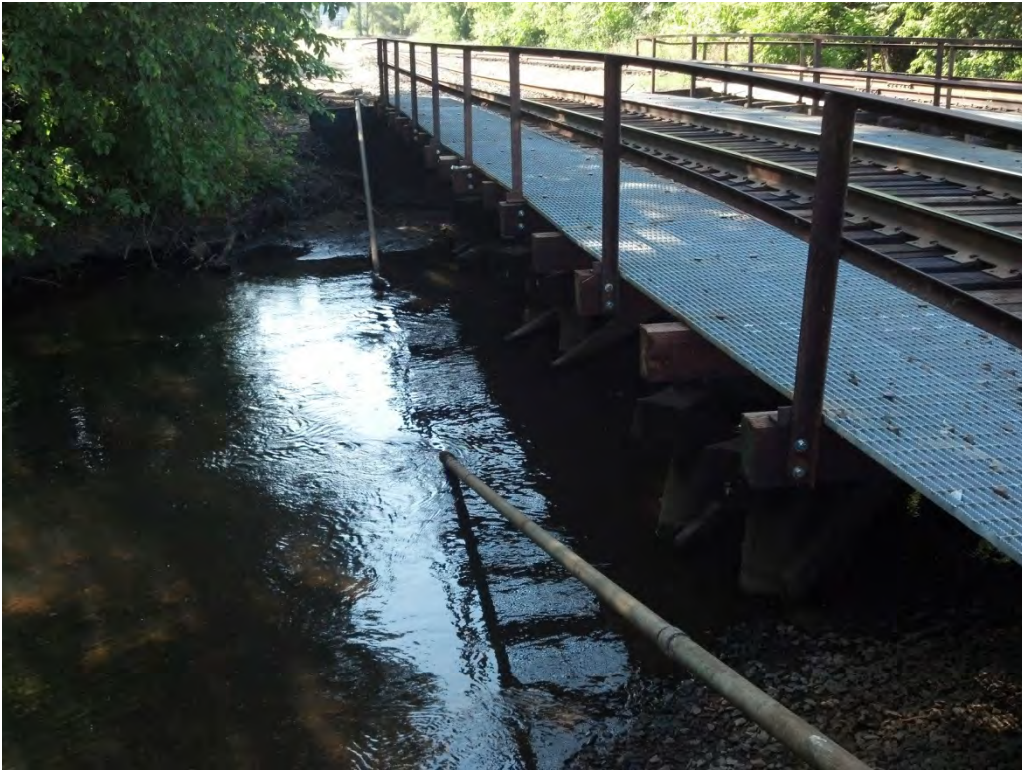
Failed conduit on north side of north structure

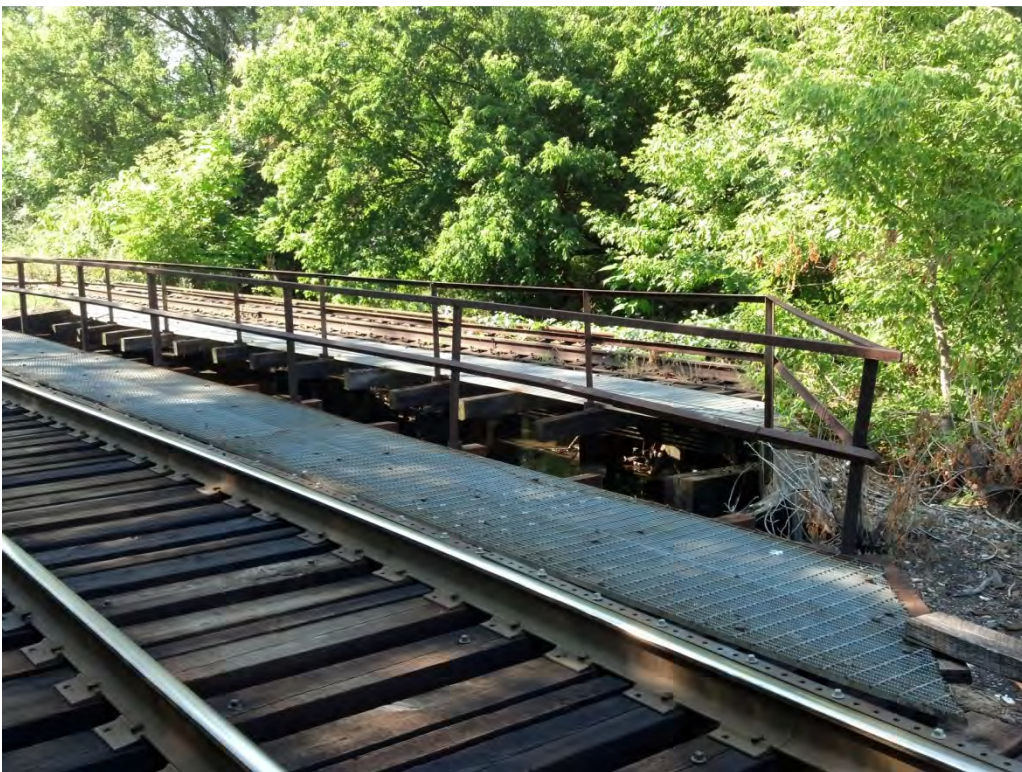
Brush growth encroaching on structure

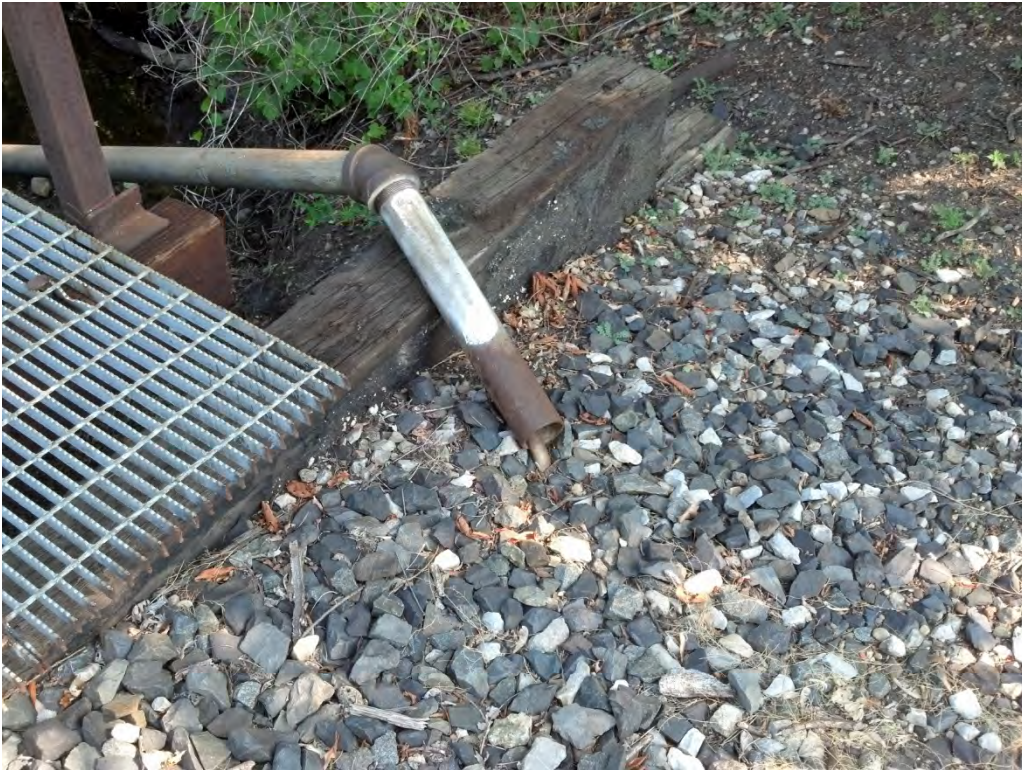
Cable inside conduit exposed at grade from conduit failure

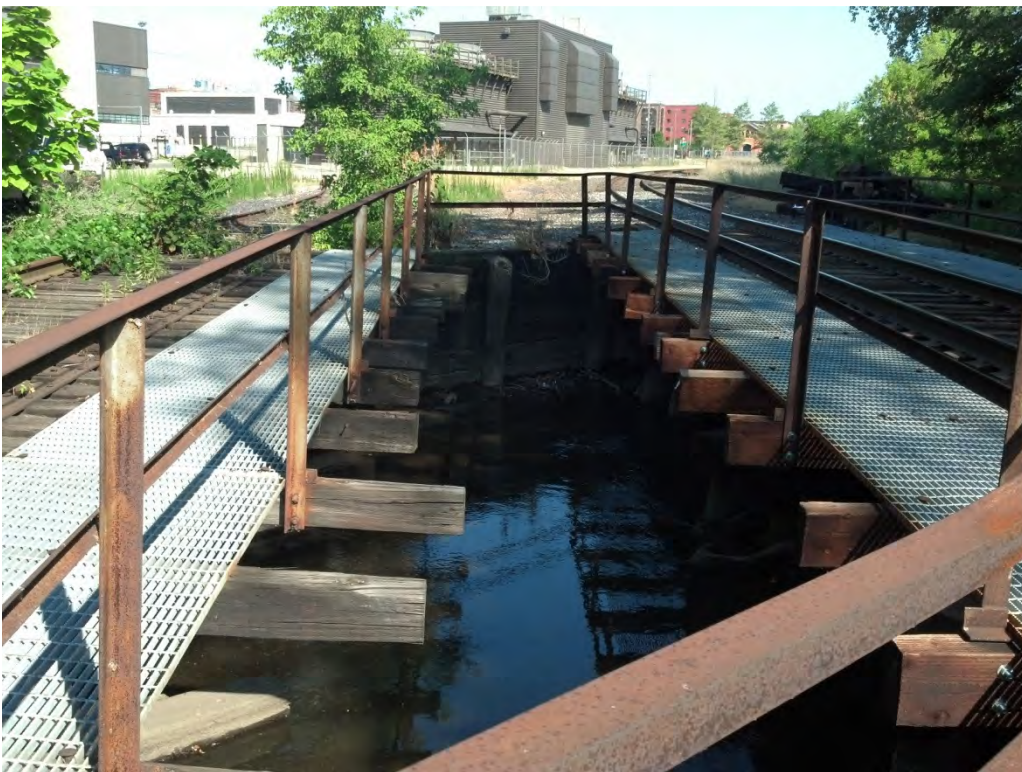
Corrosion on steel railings

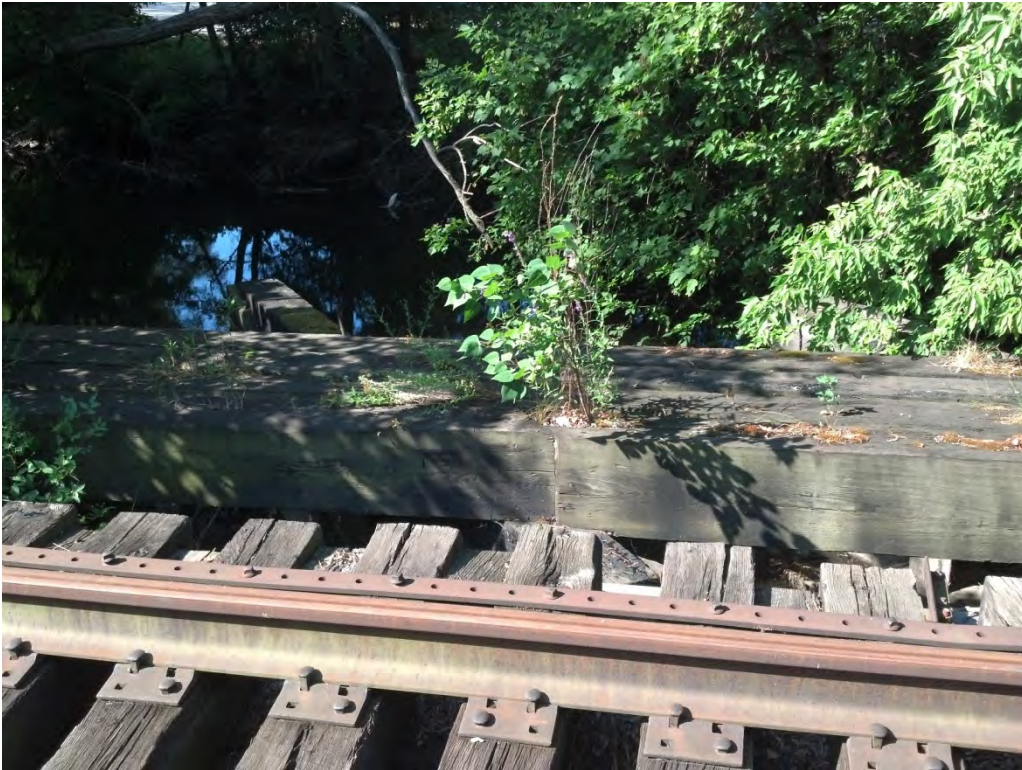
Vegetation growth in timber curb

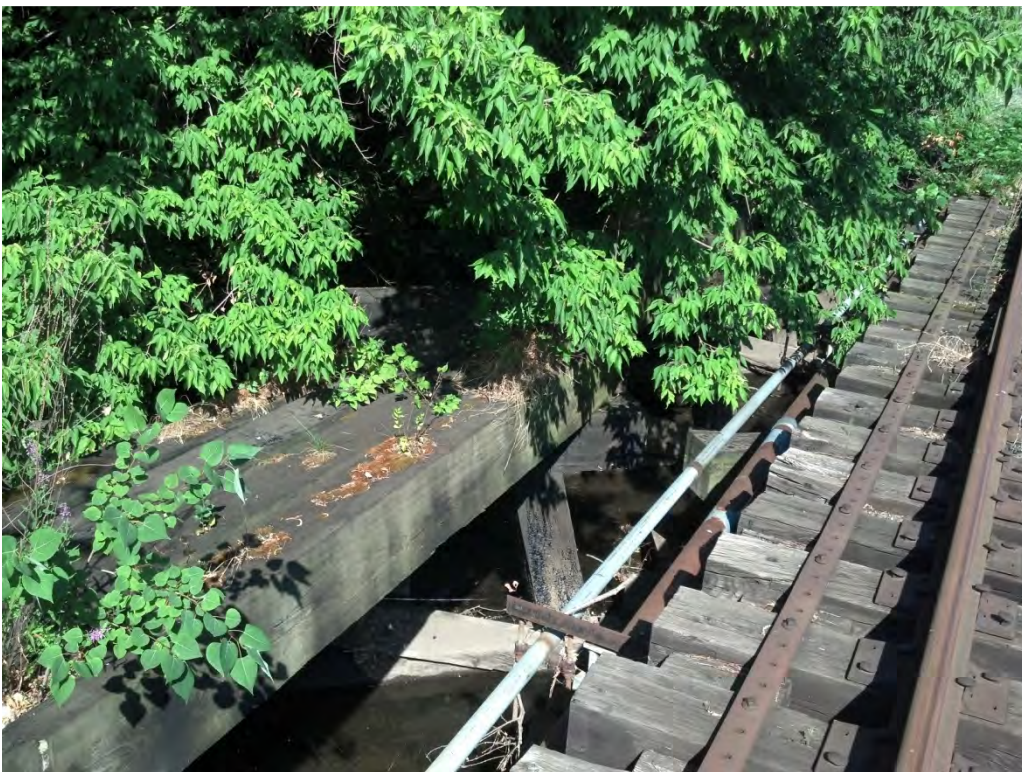
Tree and brush growth encroaching on structure

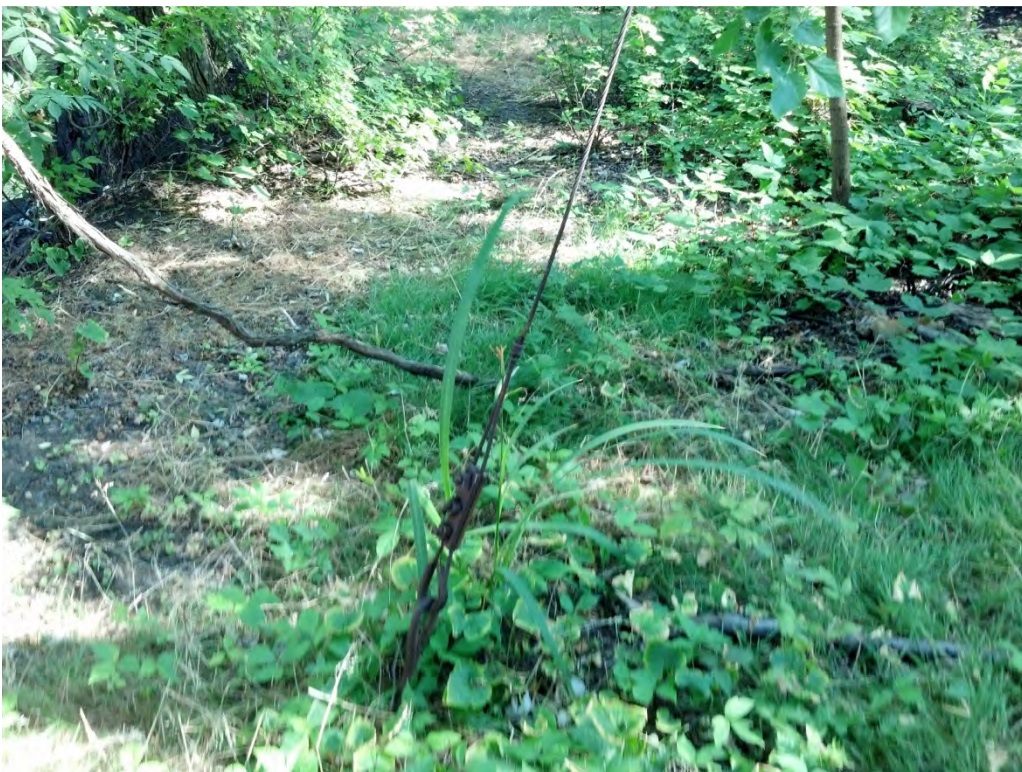
- The timber pole has minor splitting. It leans toward the channel slightly.
- The steel guy wire and support have moderate corrosion.

Corrosion on the guy wire and anchorage

- We understand that sediment removal in SA3-A will extend into this floodplain area along the east bank. Sediment should not be removed within the 1:1 influence area of the pole or guy anchor unless the pole is supported during the work.
- Construction fencing or similar means should be used to identify the pole and guy to operators and drivers during the work.

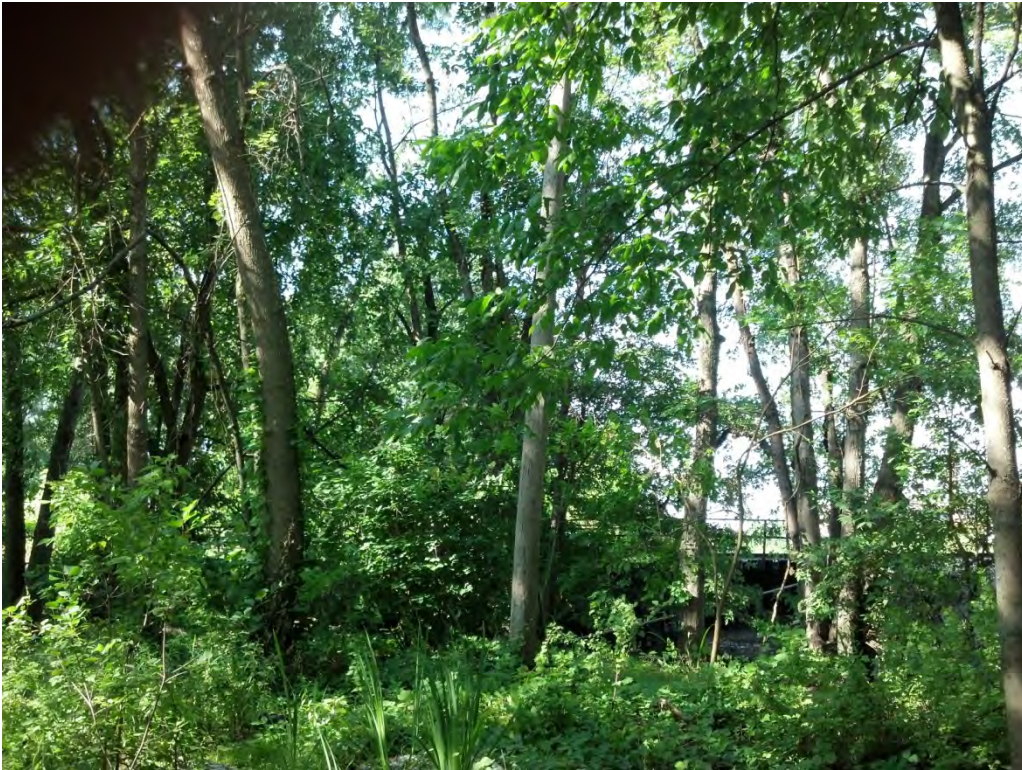
View of the pole from the north showing slight lean toward the channel

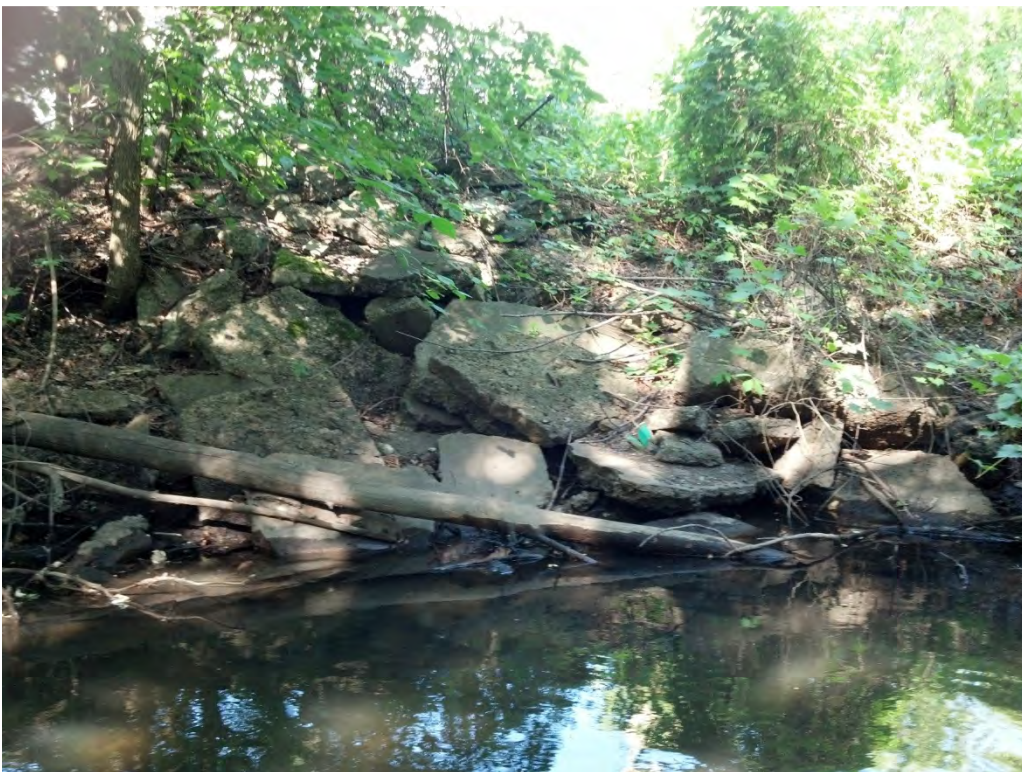
- The concrete slabs have moderate undermining along the waterline.
- A number of slabs have settled into the channel.

Undermined slabs along the waterline

- The slabs should be removed and replaced as required to facilitate sediment removal.

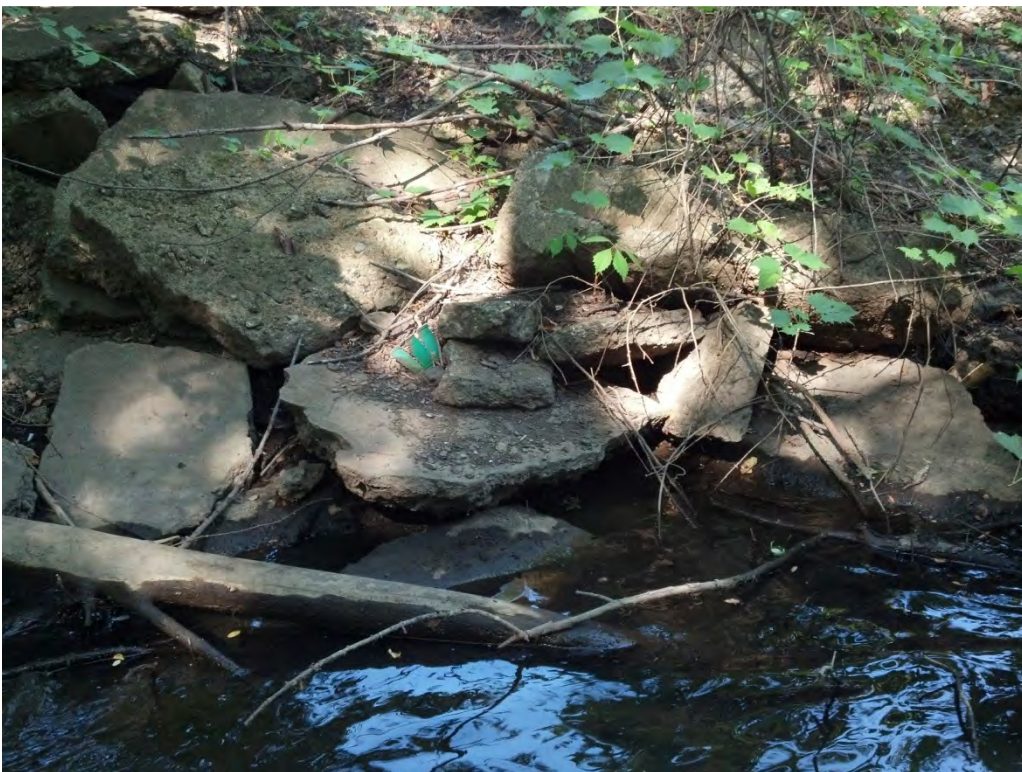
Settlement of slabs into the channel

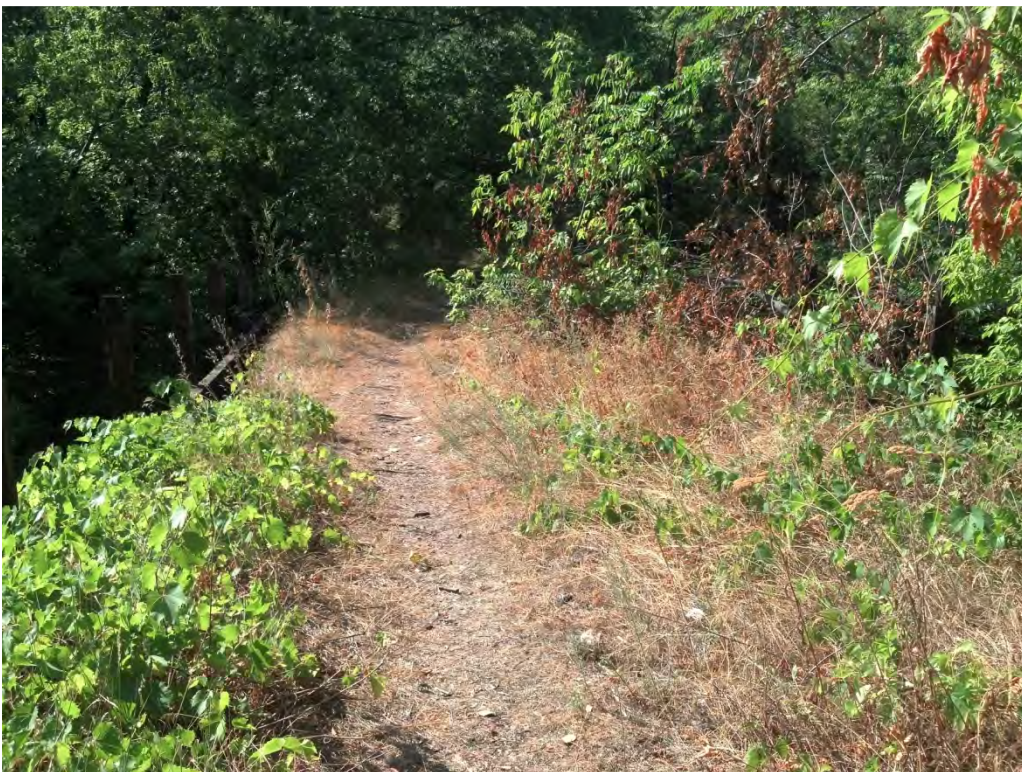
Heavy surface debris and vegetation

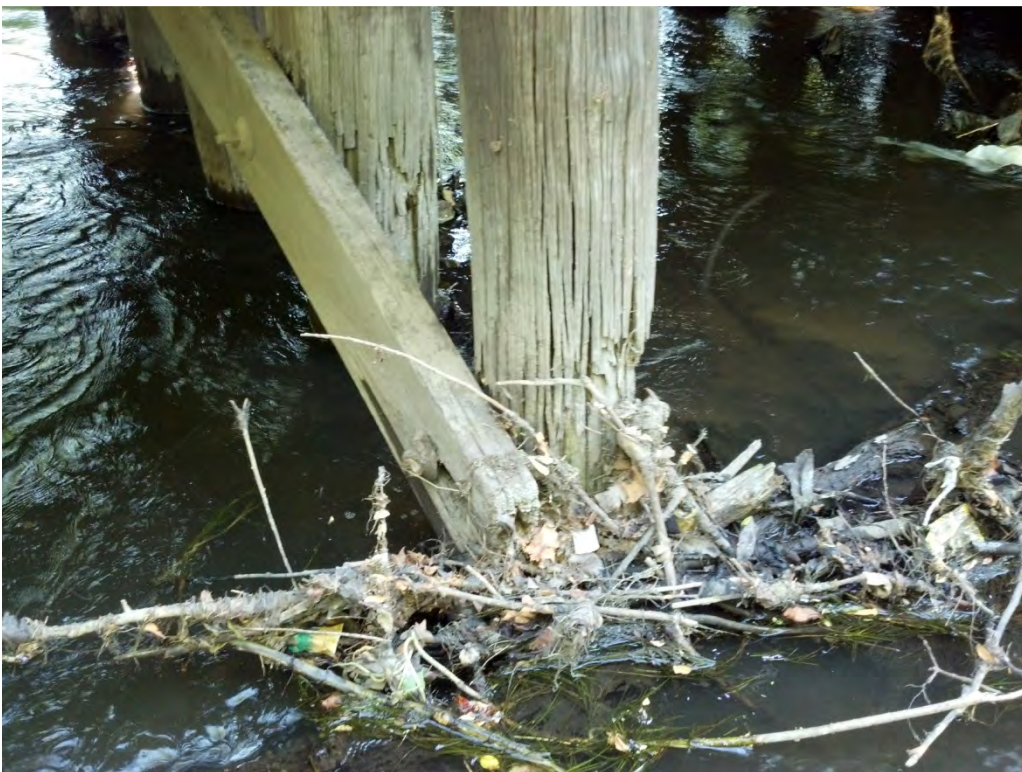
- The surface of the structure is covered with heavy vegetation.
- There is a large amount of squatter debris under the east span of the structure.
- Timber piles have various stages of section loss. The second pile from the south on the east pier has failed from progressed loss, as well as several others.
- Timber beams and pile caps have scattered splitting.
- Railings for the structure have failed.
- Moderate to severe bank erosion was noted around the structure.

Severe section loss on timber pile

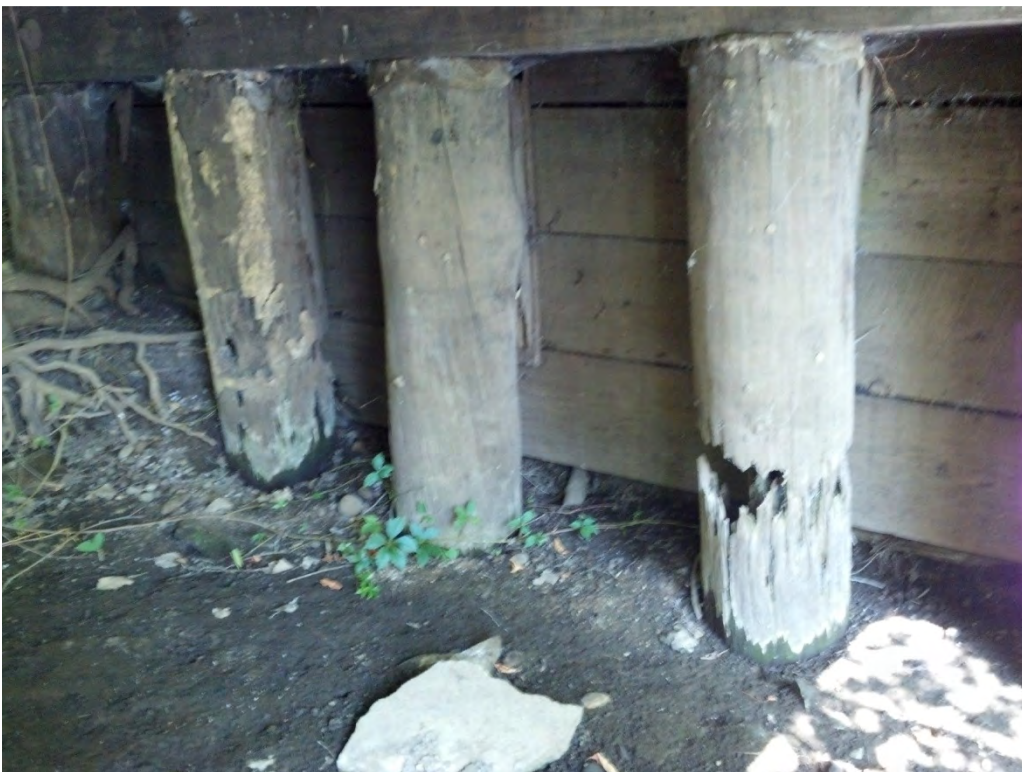
Failed timber pile at abutment

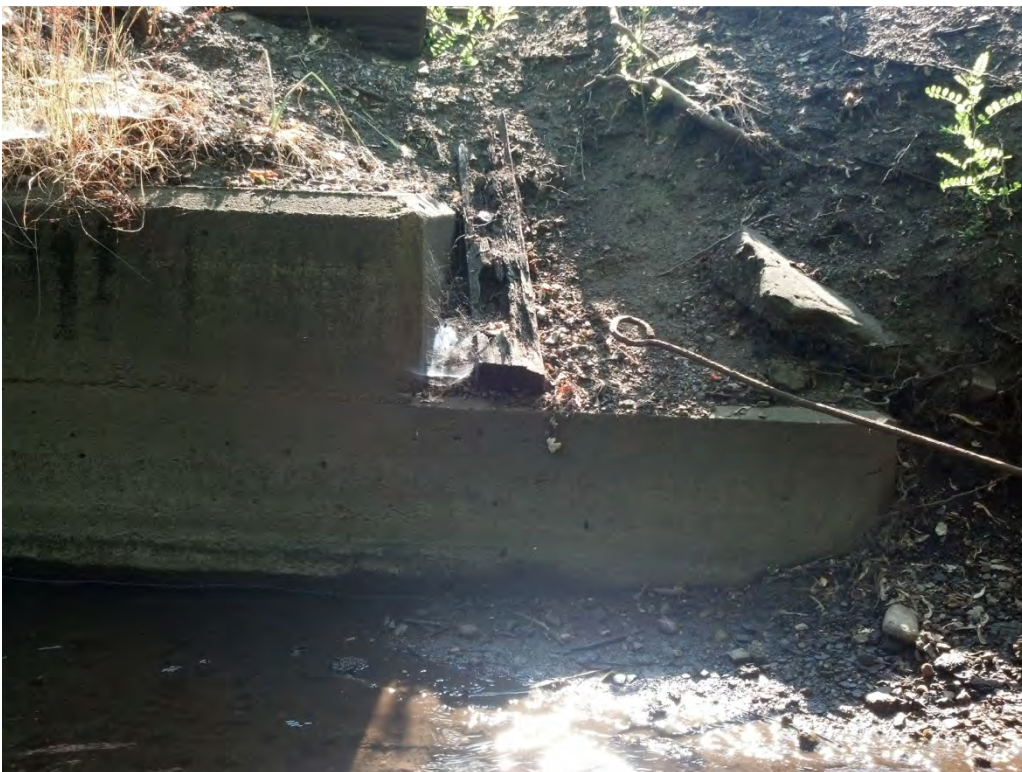
- Concrete abutments appear to be in fair to good condition.
- Moderate to severe bank erosion was noted around the structure.
- Steel girders have minor to moderate corrosion and scale. The steel bearings have moderate surface corrosion.
- The channel is lined with ballast under the structure, which has created a shallow rapid section.
- There is a large tree caught in the channel under the structure.
- The timber ties have moderate creosote bleeding.

Severe bank erosion at abutment

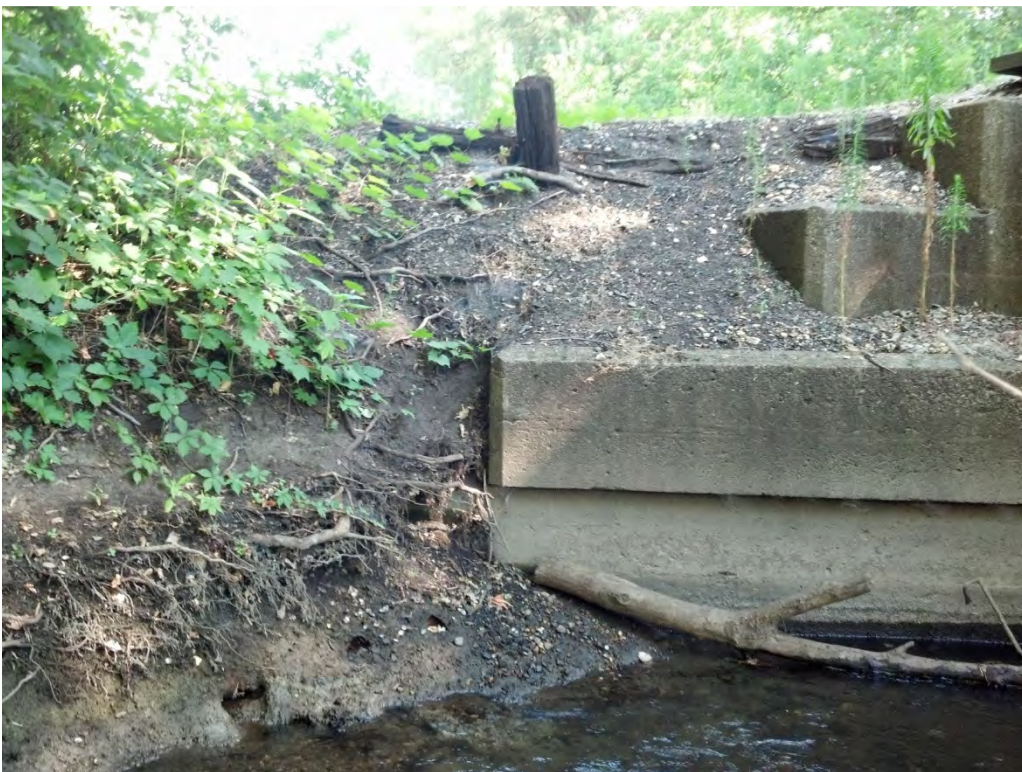
Severe bank erosion along abutment

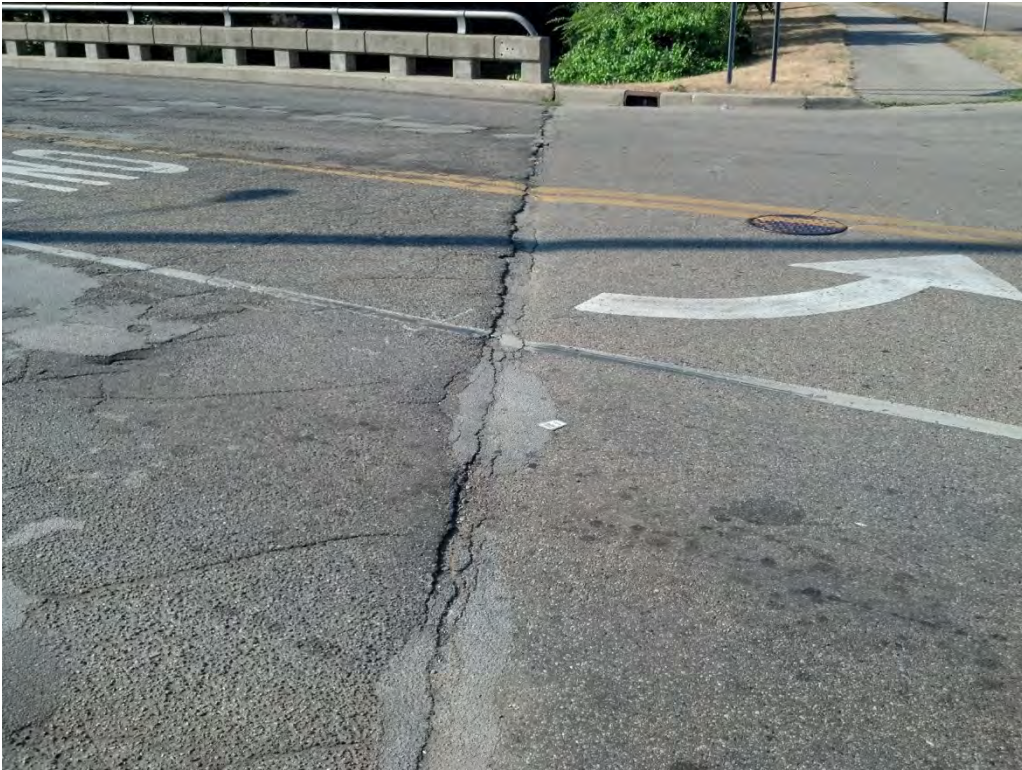
- The asphalt wearing surface is severely cracked and spalled with cold patch. Asphalt approach pavement have scattered cracking.
- The concrete sidewalk (on the north side) has moderate cracking. Approach sidewalks have moderate settlement at the structure. There is severe cracking and spalling in the northeast with exposed steel.

Cracking and cold patch along west reference line

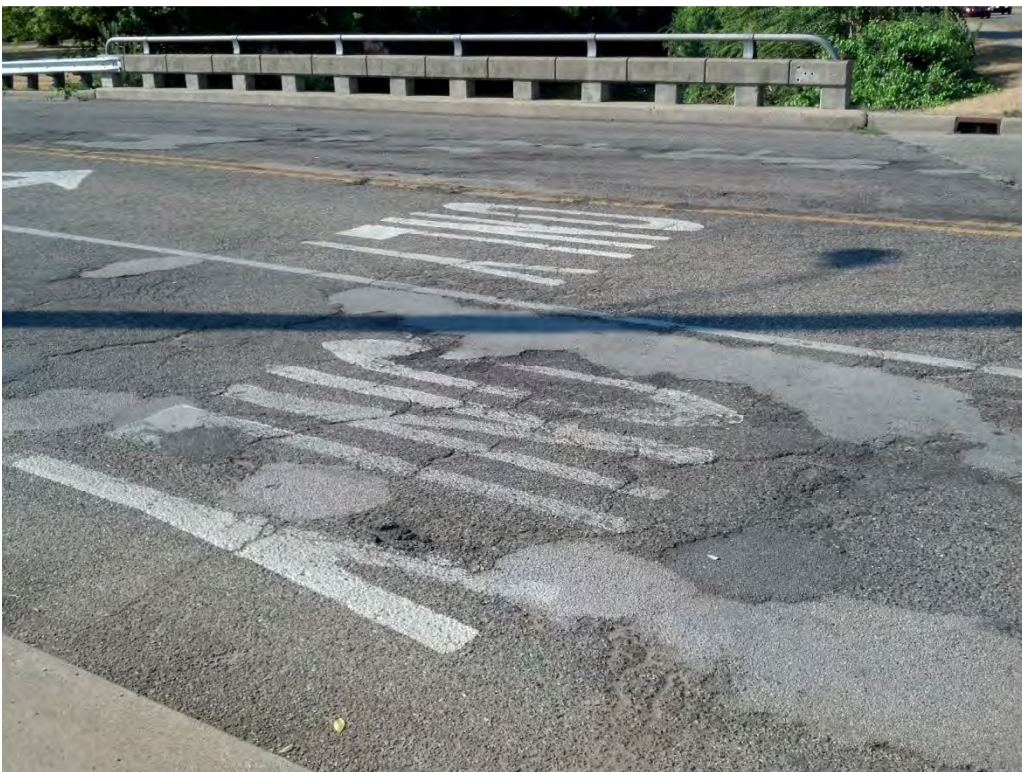
Spalling and cold patch in asphalt wearing surface

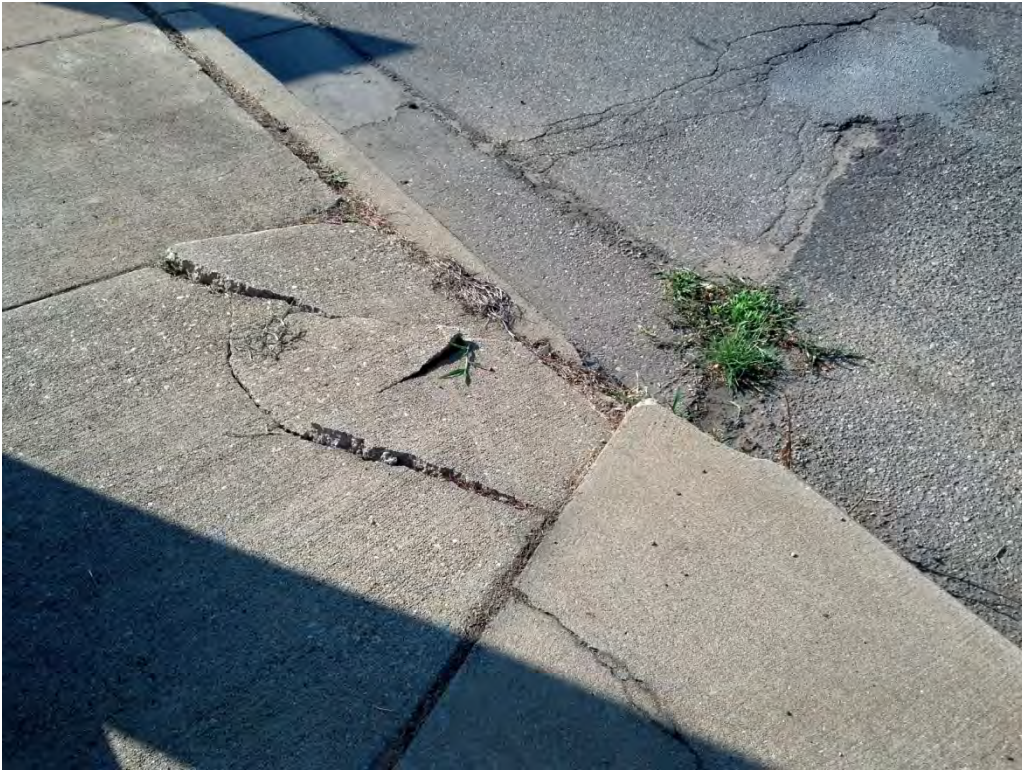
Cracking and spalling of approach sidewalk

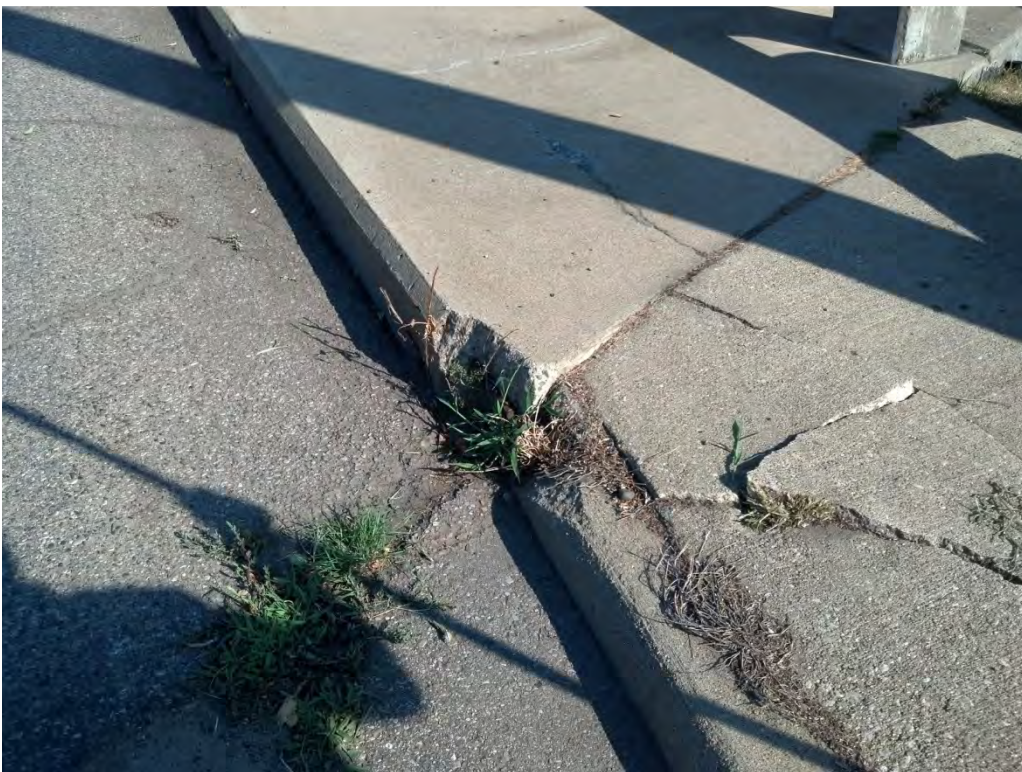
Corner spalling on curb and sidewalk in northeast

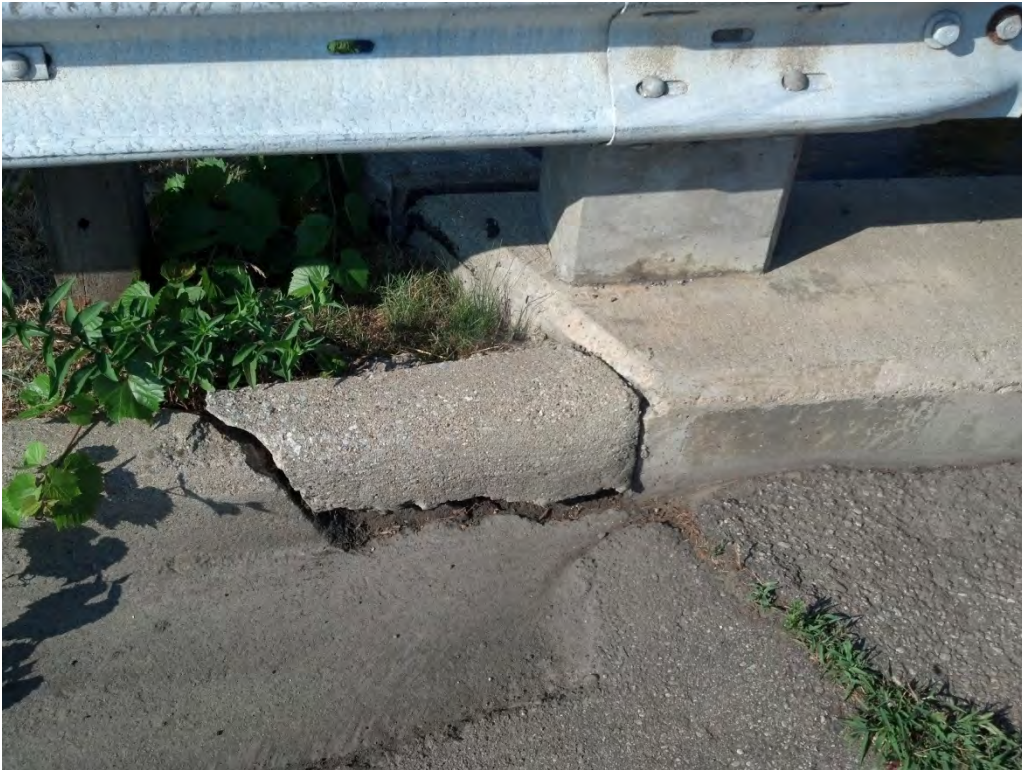
- The southeast concrete curb has severe cracking.
- The southeast guardrail has moderate collision damage and is bowed outward.
- There is a water main suspended along the south fascia.

Critical cracking of southeast approach curb
